THE   ALARM JOURNAL

April
2021

Electric shock CLAIMS

Electric shocks are the subject of a steady increase in personal injury claims.

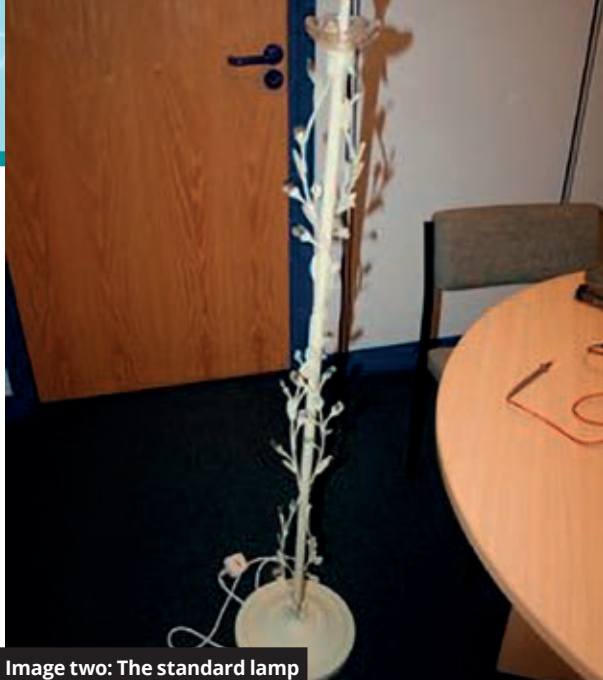
An examination of the lamp showed that it had a three-core supply cable, (the metal parts of the lamp being connected to earth by the third conductor). It was found that the supply cable was poorly terminated at the lamp holder, so strands of its live conductor were not fully inserted into the terminal and were hanging out of it. Microscopic examination of the ends of the loose strands indicated that some had a melted appearance and there was evidence of minor electrical arcing activity on an internal earthed part of the lamp holder.

Image two: The standard lamp

The Claimant purchased a new standard lamp (see image two) from a reputable retailer. After unpacking it she connected it to a mains socket outlet and switched on the socket outlet. She then realised there was no light bulb in the lamp. It was reported that 'as she went to switch the lamp off at the mains socket, she received an electrical shock that threw her approximately four metres across the room'. Her account is that she was around 30cm away from the lamp at the time of receiving the electric shock, so she reported not touching the lamp at the critical time.

However, the physical evidence showed the live conductor was poorly terminated inside the lamp holder, and evidence of abnormal electrical arcing activity between the loose strands and the lamp holder. It was, therefore, apparent there had been a short circuit fault to earth inside the lamp. As a result, the lamp body would have probably become electrically live for the period in which the circuit protection took to operate.

The circuit protection comprised a 3A plug fuse, a 32A MCB and a 30mA RCD. As the plug fuse had not operated, it follows the RCD probably did so as that device would be expected to act in response to the short circuit fault to earth. That device should have operated within 0.3 seconds, and there was, therefore, only a short time in which a shock might be felt.

In summary, the evidence showed there was a manufacturing fault on the lamp that had the potential to result in an electrical shock. As a result, it was considered a credible claim.
