Risks of modern methods of CONSTRUCTION As the various types of modern methods of construction

As the various types of modern methods of construction are more commonly used, the risks associated with new materials and systems become better known.

AUTHOR: Neil Sanders, Partner, Burgoynes

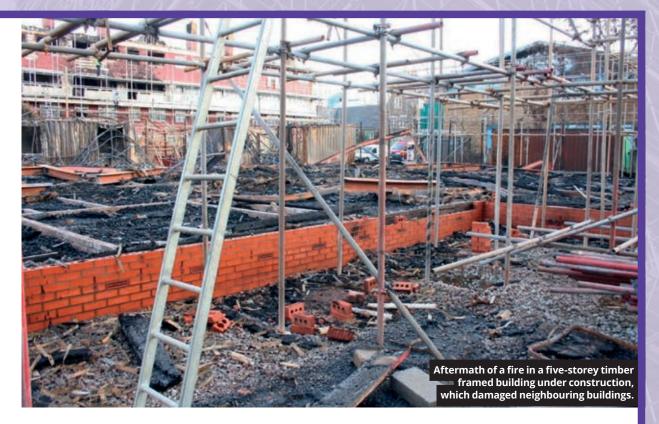
Water ingress and water escapes may cause relatively severe damage in timber framed buildings. This is partly because water can penetrate downwards more readily than with some traditional constructions such as concrete floors. Also, timber frame construction may require more remedial work than traditional construction.

Completed timber framed buildings can be vulnerable to extensive spread of fire via timber-faced voids that are naturally part of the construction. These voids should be properly fire-stopped, but in practice this may not happen due to a combination of design issues; difficulties with the initial installation of the fire stopping; disturbance of installed fire-stops by following trades; and lack of effective supervision and/ or inspection. Damage to room-lining plasterboard during occupancy can also allow fire to spread too easily into timber-lined voids. In these cases, resulting damage may be extensive, even if the initial fire is not particularly large or severe.
