# Fire!

A guide to the causes and prevention of cargo fires

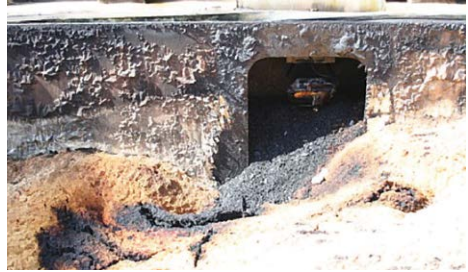
There were two floodlights fitted in cargo hold 1, port and starboard and four floodlights fitted in both cargo holds 2 and 3. All the floodlights were installed in recesses in the hatch coaming. The floodlights were protected by round bars preventing crane hooks, grabs etc from hitting them, but these bars do not prevent cargo like sugar beet pellets from

covering the lights. The floodlights were controlled from the bridge on a panel with four key-switches. These switches were marked 1, 2, 3 and 4 respectively. No drawings or legends were attached clarifying which areas these key-switches served.

The top layer of cargo in hold 2 had been burned. About four metres below the cargo surface the cargo was in good condition. It was discovered that the cargo in hold 3 had been damaged by condensation and tainted by smoke. There were clear burn marks around the floodlights and distinct burn marks by the coaming at the same locations where the hot spots had been discovered. The floodlights were situated 1m below the cargo surface in holds 2 and 3 and there was black, burned cargo covering the floodlights.

The subsequent investigation revealed that the cargo floodlights were not connected according to the approved 'as built' circuit diagrams delivered with the vessel.

It was not clear on board which lights were controlled by which key-switch. The fire was caused because a number of cargo lights were operating while cargo covered them, so the lights ignited the cargo. There was a lack of information on board about how the light circuits were connected and how the light system should be operated. There was also a lack of records concerning use of the lights.
